# SOFTY 2 Memory Map

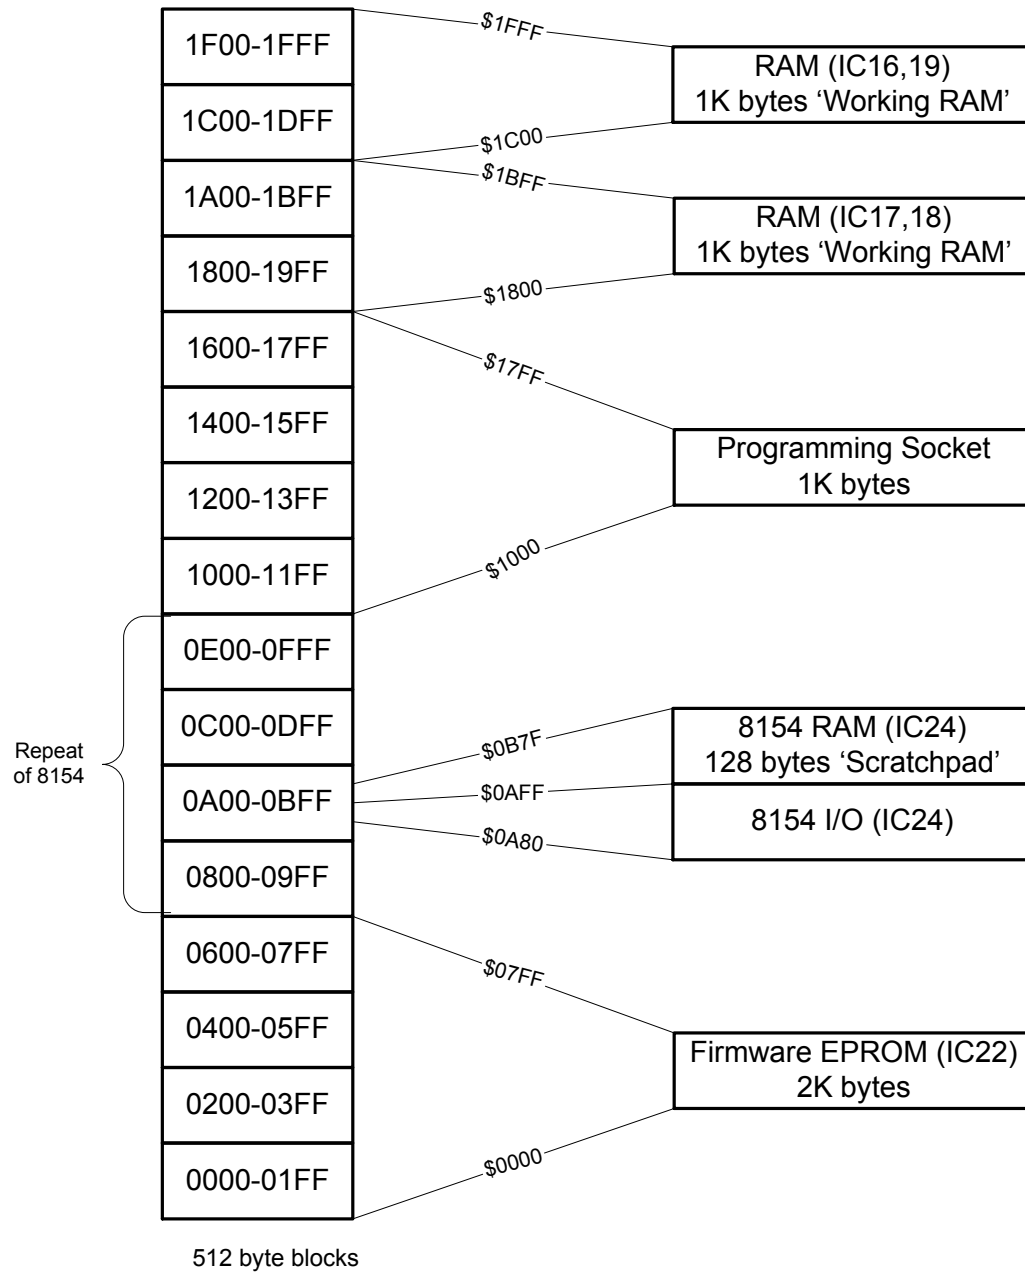
A7 driving the 8154 M/IO pin is inverted hence RAM and I/O are swapped from normal.

The 8154 repeats 8 times because of incomplete address decoding, typically addressed as shown here.
